SOUTHEAST LONGMONT CONDITIONS SURVEY

Longmont, Colorado

JULY 2006

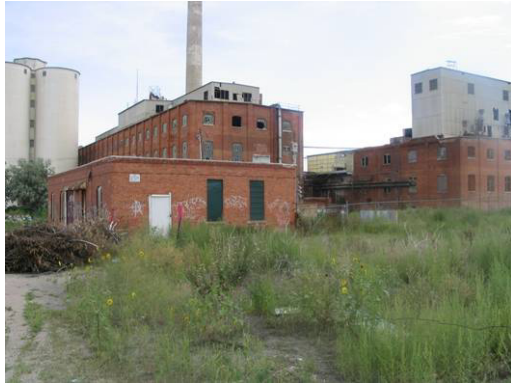
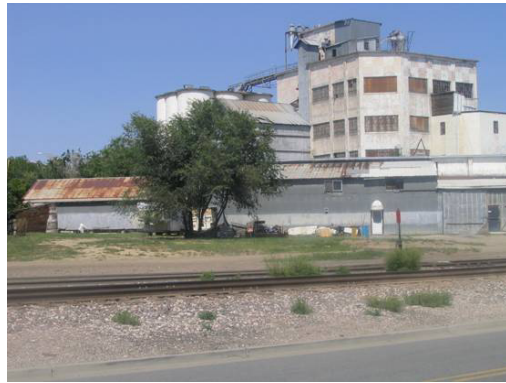
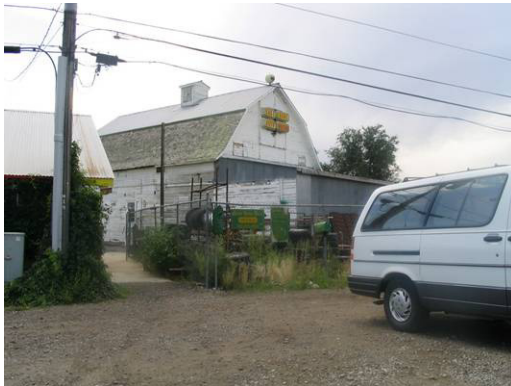
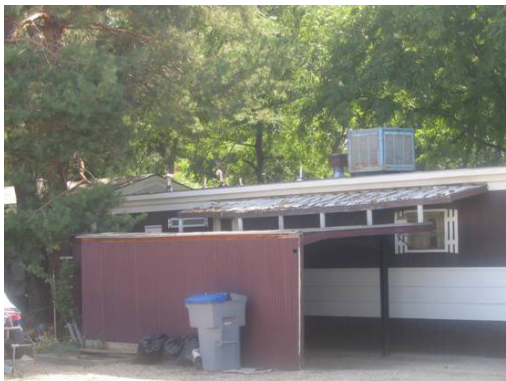
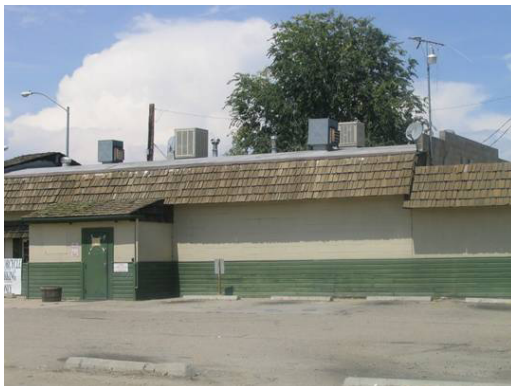
Although structural deterioration is most pronounced and obvious at the old flour mill and old sugar mill sites, examples of this condition can be found within properties throughout the study area. The most common examples of structural deterioration found in the Study Area involved poorly maintained exterior finishes, and fascia and roof

deterioration Many properties were observed to have outbuildings in disrepair. Some older properties were also found to have window, roof, and wall deterioration. Other Study Area structural problems, though less common, include deterioration of exterior walls, gutters, fences, mechanical equipment and loading areas. Examples of properties affected by Condition (a) are shown in the photos below.

In addition to the mill sites, this condition is most prevalent at salvage yards, industrial sites, and with residential structures located adjacent to industrial uses.

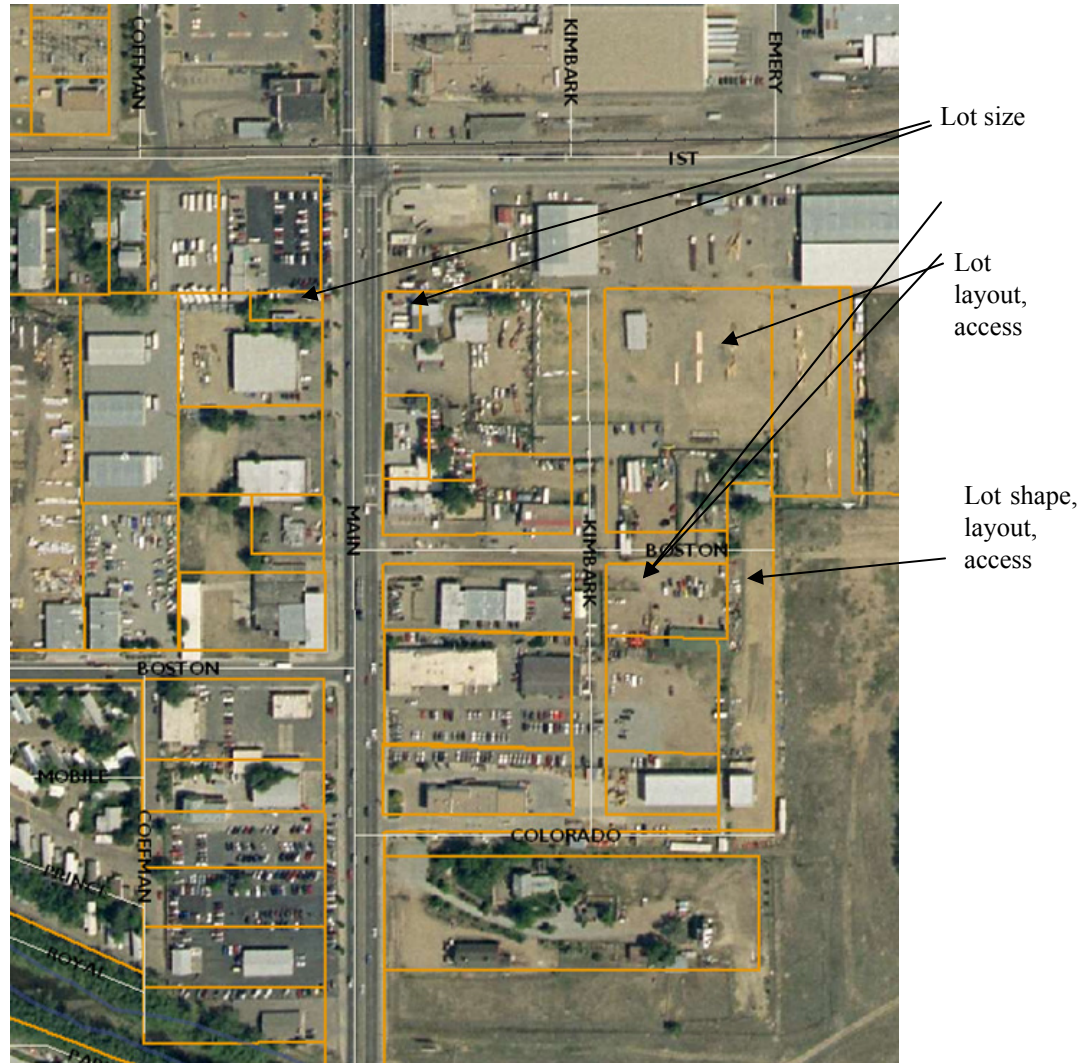
Examples of Condition (c)

Faulty lots can be found throughout the eastern portion of the study area as a result of layout, shape and access issues. Lots between Kimbark Street and Emery Street in the study area also suffer from poor access and layout.

The aerial photograph presented below illustrates several examples of faulty lots in the Study Area, as per the statute Condition (c).

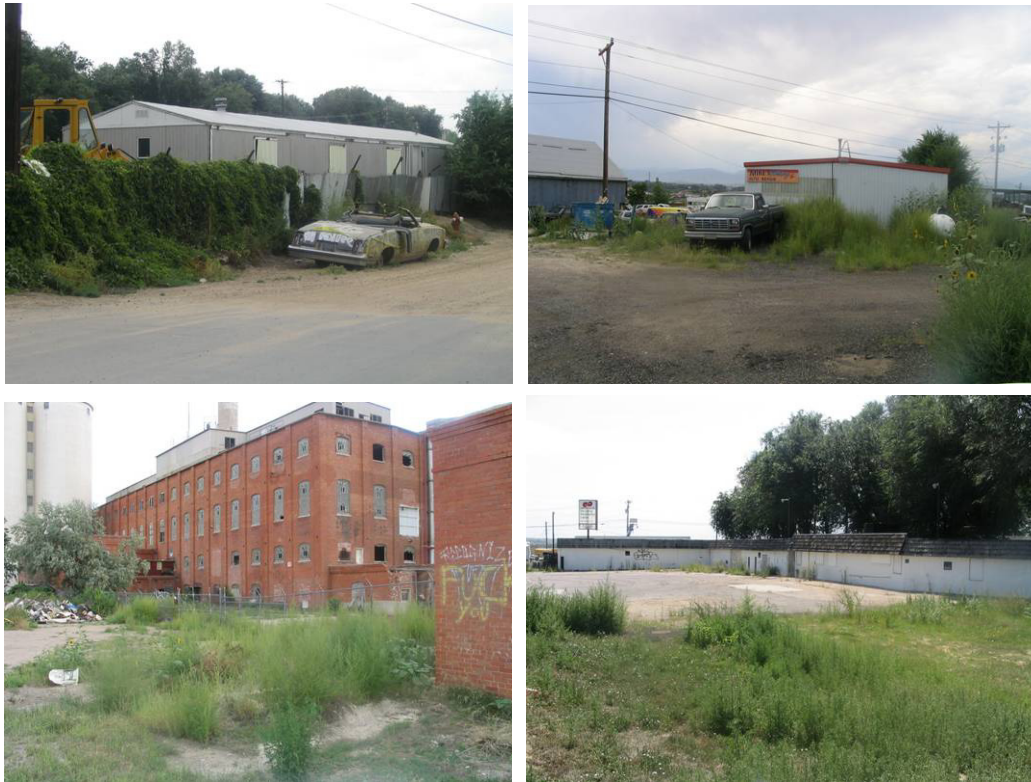
Poorly lit areas are prevalent throughout the Study Area particularly in large vacant parcels, parking lots in front of or behind older businesses, and industrial parcels in general. Problems with unscreened trash and mechanical equipment can be found throughout the Study Area as well, most commonly on property around older industrial and salvage businesses and in large vacant areas.

Examples of parcels exhibiting condition (d) are shown below:

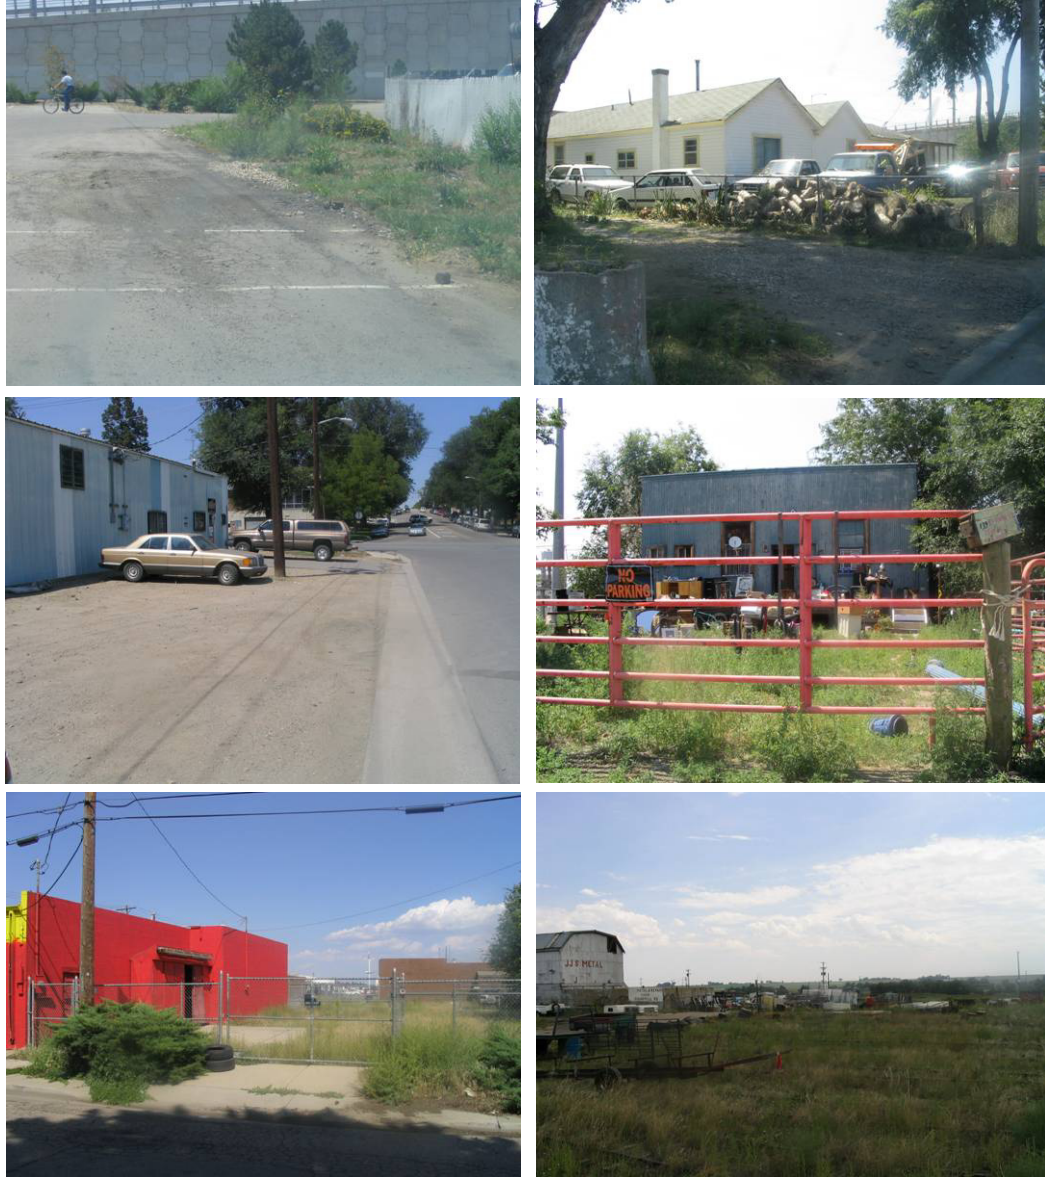
Examples of Condition (e)

A variety of blight conditions were observed within the Study Area related to the deterioration of the site and non-primary improvements. These conditions which negatively affect the appearance and utilization of the area, most commonly include parking surface deterioration and unscreened trash and mechanical equipment. Several sites were found to have site maintenance problems, a lack of landscaping, or signage problems. Although this condition was most prevalent in older industrial properties and salvage yards, examples of site deterioration problems are found throughout the Study Area, as shown in the photographs below and detailed in the maps and field inventory.

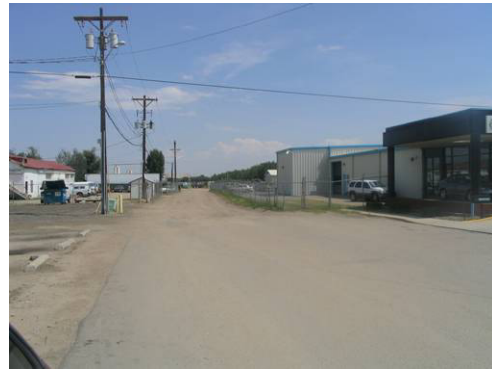
A primary condition related to inadequate public improvements involves street pavement deterioration and lack of paved streets. Additionally, almost all parcels are considered, for purposes of this analysis, to have outdated power and phone system provision because of the reliance on overhead utilities. This is considered to be an impediment to modern development and redevelopment in the current real estate market.

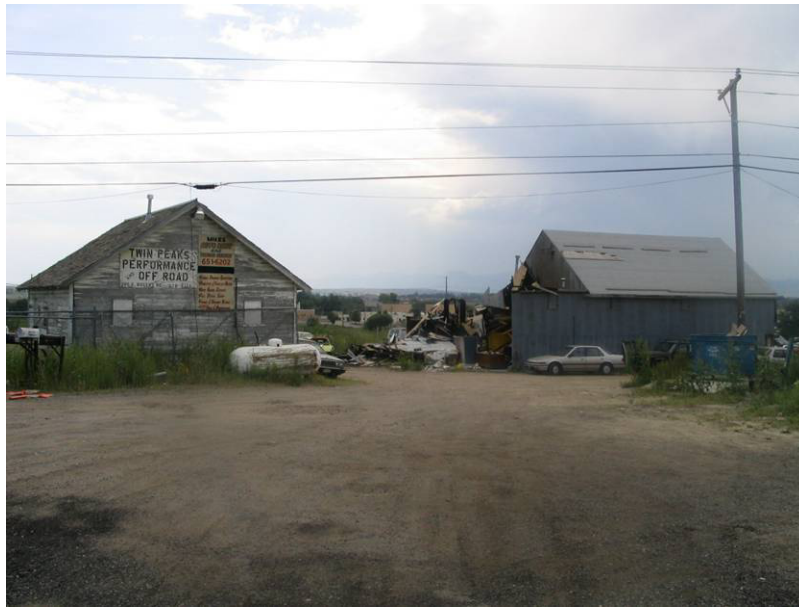
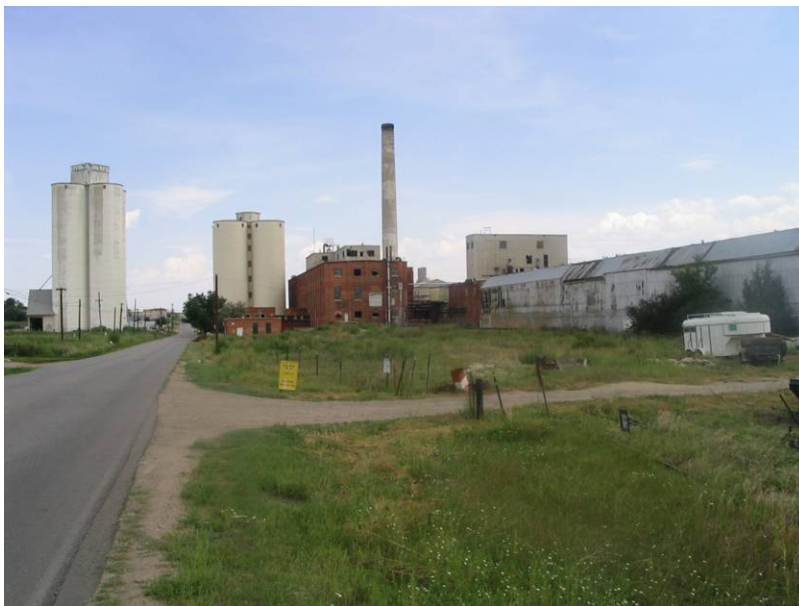
Examples of Unsafe or Unhealthy Building Conditions

Although no interior inspections were conducted as a part of this analysis, a few properties, shown on the map, were considered sufficiently dilapidated and unsafe, based on outside appearance, as to qualify under this condition.

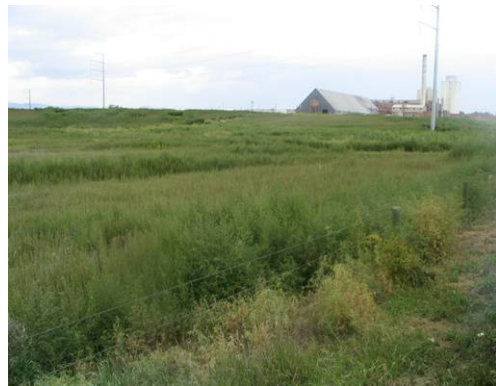
The Study Area includes 34 parcels with either vacant land or vacant buildings-- a sizable portion of the total inventory, totaling approximately 278 of the 445 total study area acres. These properties are considered underutilized for the purposes of this analysis. Note that 13 of these properties, constituting 181 acres, are on land currently outside the Longmont city limits.
