BUTTON ROCK PRESERVE MANAGEMENT PLAN

Prepared by
City of Longmont
Natural Resources Division

with
Colorado Natural Heritage Program
DHM Design
RiverRestoration

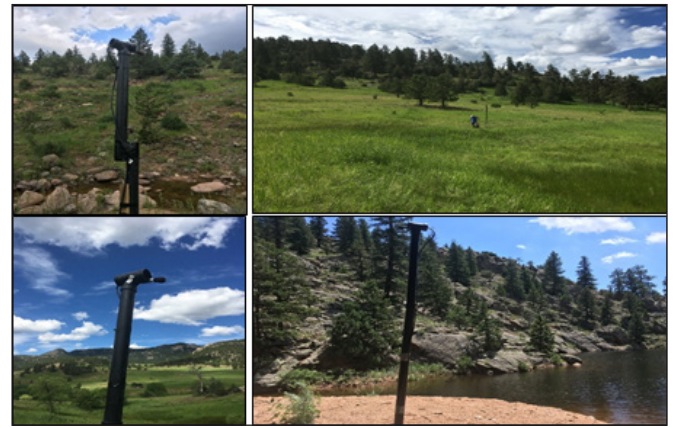
Figure 24. Views from bat acoustic monitoring sites located across the Preserve. Site A (top left): Small stream located at the upper end of Rattlesnake Gulch. Site B (top right): Opening adjacent to the large pond heavily vegetated with willows. Site C (lower left): Small pond in the Button Rock Dam ‘borrow area’ meadow, Site D (lower right): Lower end/mouth of Rattlesnake Gulch opening into Ralph Price Reservoir.

In July 2019, four stationary acoustical monitoring stations were established for a total of 15 days. The stations assessed bat use and distribution on the Preserve. The location of each monitoring station was selected to maximize the number and quality of recordings. Therefore, detectors were placed in areas with high potential for bat foraging activity, with little to no vegetation “clutter,” i.e., vegetation density at the mid and upper canopy level, allowing unobstructed flight paths, near open water areas likely used for drinking and foraging, and away from fast flowing streams that produce too much competing noise, e.g., North St. Vrain Creek (Loeb et al., 2015 as in CNHP, 2019). Song Meter SM4BAT FS ultrasonic detectors (Wildlife Acoustics, Inc., Maynard, MA) were used to continuously record nighttime bat echolocation calls (Figure 24). Resulting bat call files of sufficient quality were identified to species using SonoBat v.4.2.2.1.

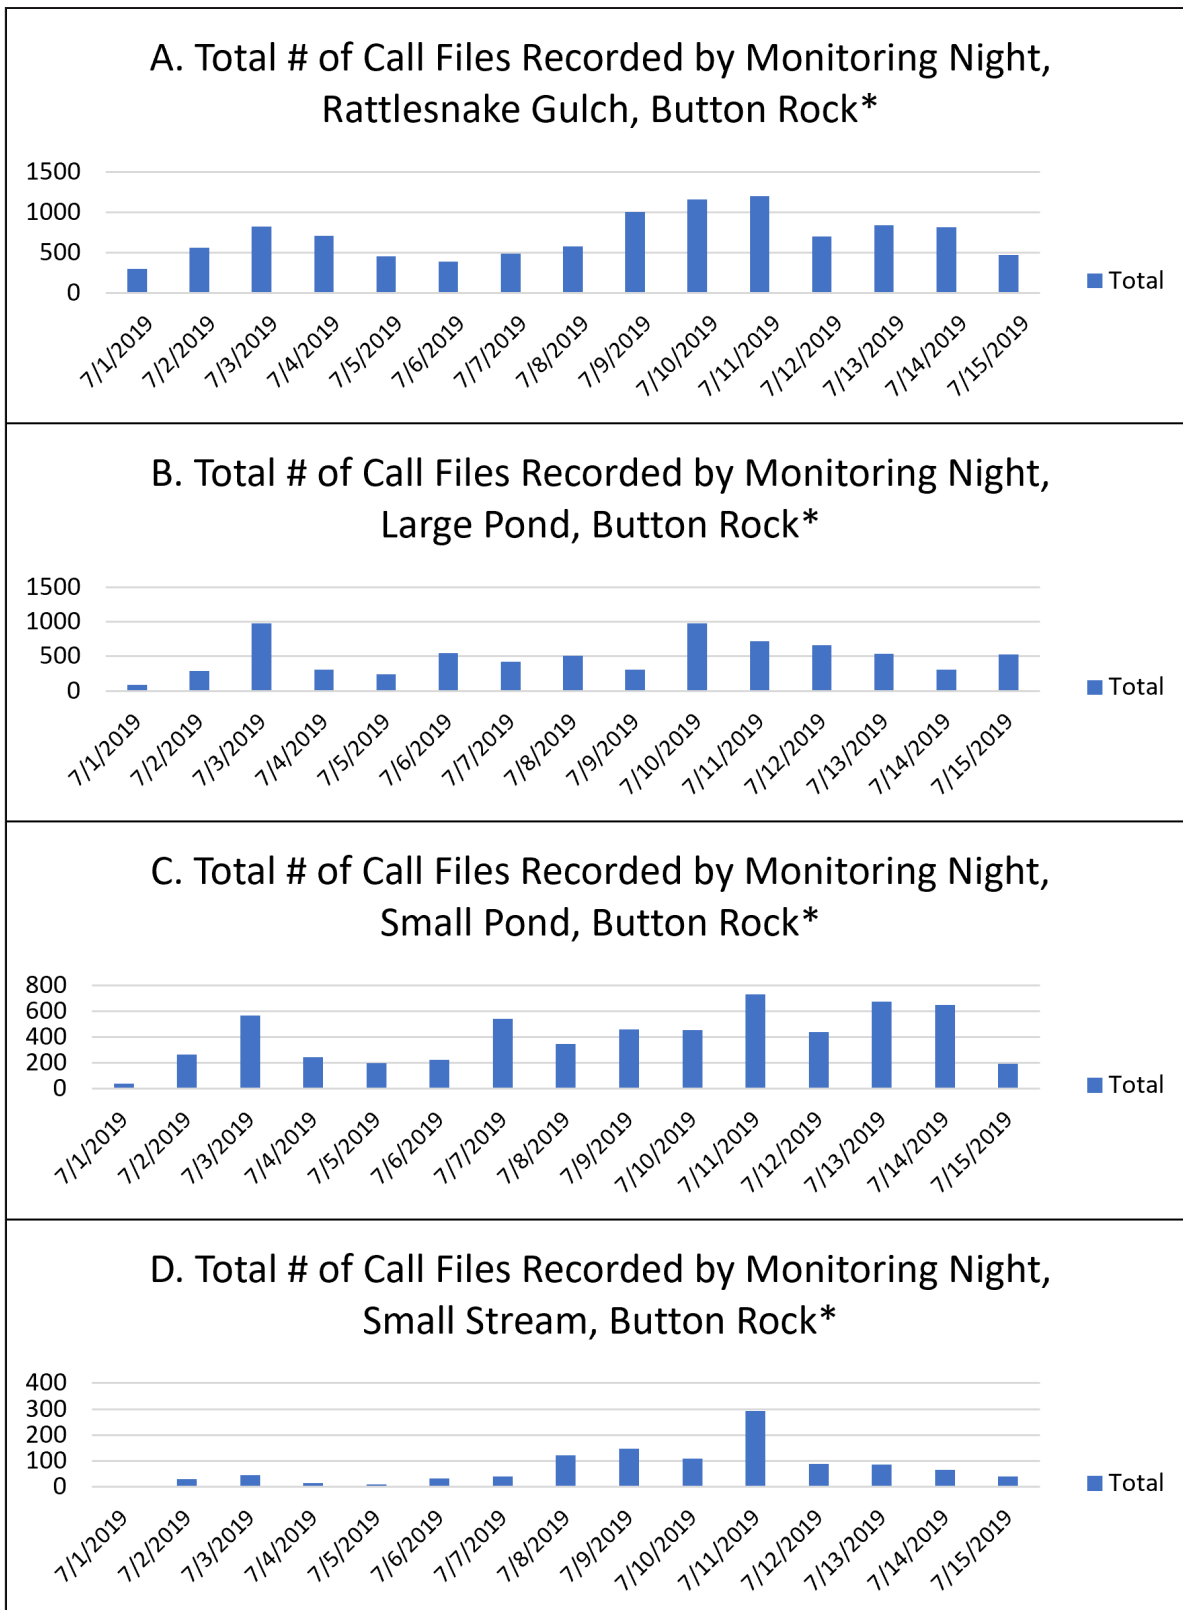
Figure 29. Bat call files recorded by Song Meter SM4BAT FS acoustic detectors at 4 Button Rock Preserve sampling locations. *The counts represent call files that received an identification from the SonoBat autoclassifier.

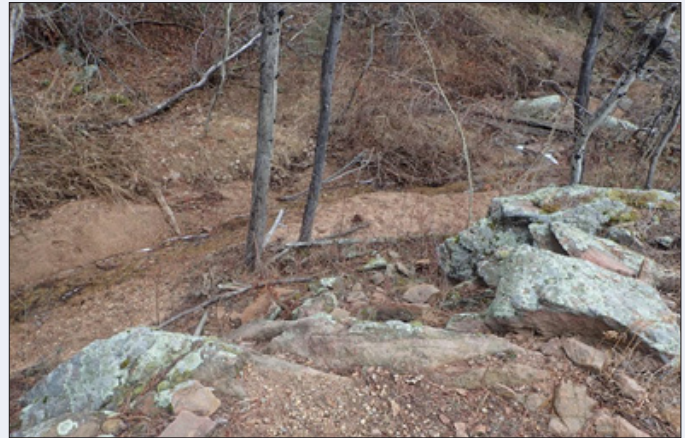
Figure 31. Sand and gravel deposits in channel from adjacent road/trail (Photo CT6, RiverRestoration, 2019).

The stream channel width ranges from two to six feet and channel substrate ranges between relatively fine material up to small boulder size. There are pool sections, gravel bed riffles, boulder gardens, bedrock cascades, and dense in-channel vegetation including aspens and other trees. The banks and floodplain are vegetated with willows and other shrubs, grasses, and large trees. Where the trail follows the stream, gravel and sand material have eroded from the trail and deposited into the streambed and onto the overbanks (Figure 31). While there are several locally

eroding banks along the channel, the erosion is not widespread or systemic. However, the gravel trail surface material may be a significant source of sediment to the stream system and may impact the creek function and ecology of the reaches.

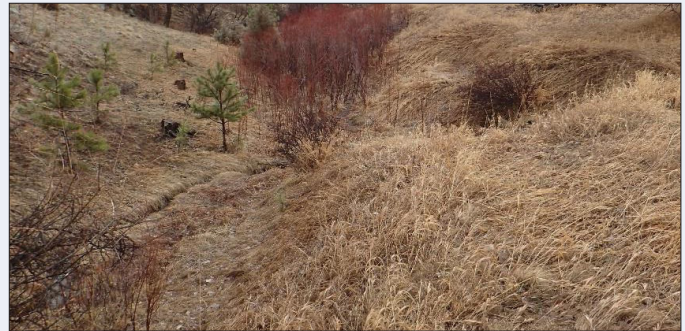
Figure 32. Typical channel section with dense grasses on streambanks (Photo CMG07, RiverRestoration, 2019).

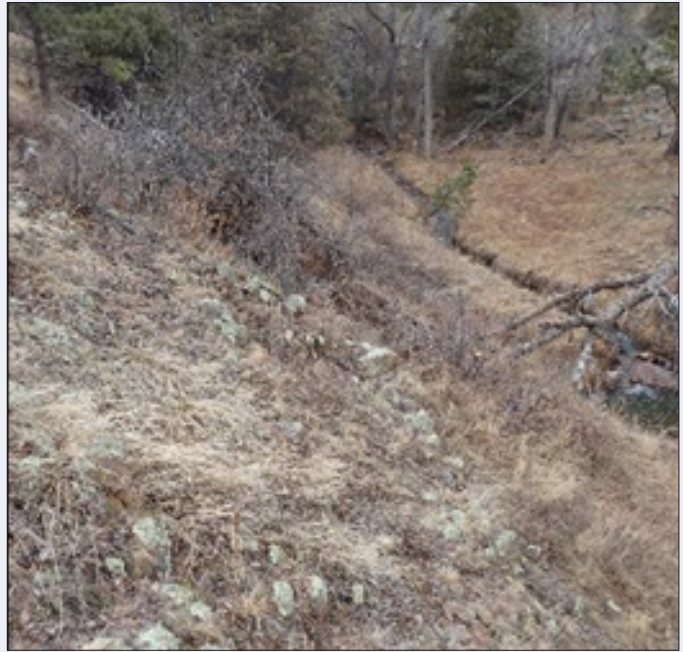
Figure 33. Typical upstream channel section, narrow with dense grass covered channel form (Photo CGO1, RiverRestoration, 2019).

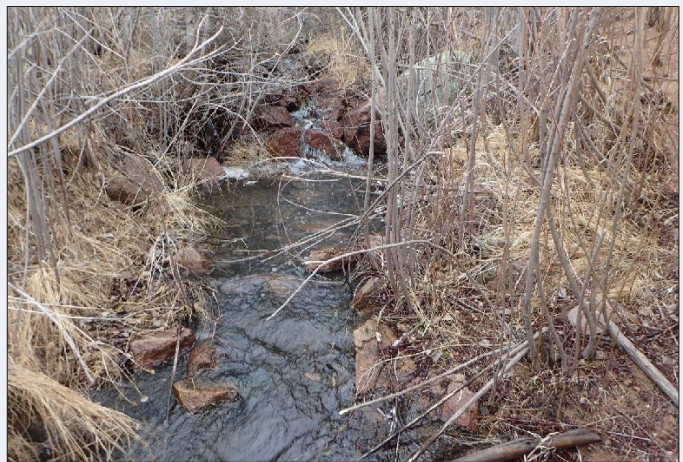
Figure 34. Typical downstream channel section near confluence with North St. Vrain Creek (Photo CGO4, RiverRestoration, 2019).

The channel in the upper sub-reach is shallow, flowing through a sparsely forested valley bottom with a mild bed slope and more gradual side slopes (Figure 33). Channel substrate ranges from fine sands up to large cobble with periodic boulder rock fall and bedrock. The lower sub-reach has a distinctly steep bed slope, a deep channel, and steep side slopes. The grade is controlled in areas by large boulders and periodic granitic bedrock outcrops. These controls form what can be characterized as a step-pool morphology (Figure 34).

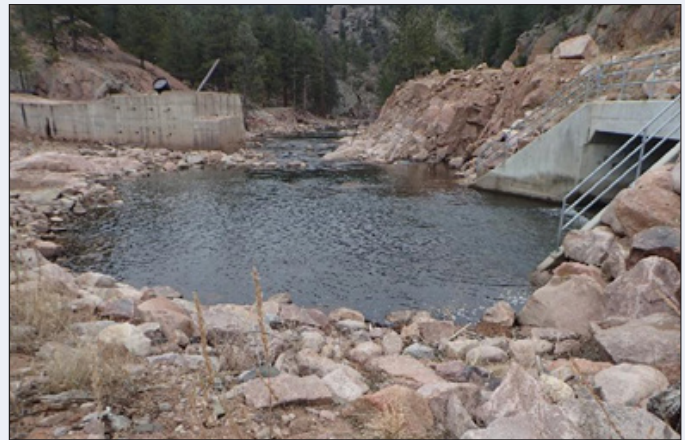
Figure 35. Concrete box culvert under road and Chimney Rock Dam (Photo DSSV08, RiverRestoration, 2019).

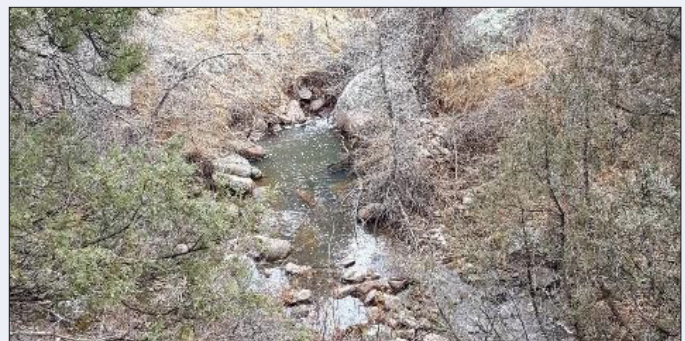
Figure 36. Typical channel form in upper reach (Photo HR01, RiverRestoration, 2019).

are not composed of granite boulder and bedrock, a shallow topsoil mantle stabilized by pine needles, leaf litter and roots meets the streambed at a variety of side slopes up to vertical. The banks and floodplain are primarily vegetated with shrubs, grasses, and large trees (Figure 36). In general, the stream is stable and does not appear to transport significant quantities of sediment into the Downstream North St. Vrain Creek. There is no evidence of point source or other pollution.

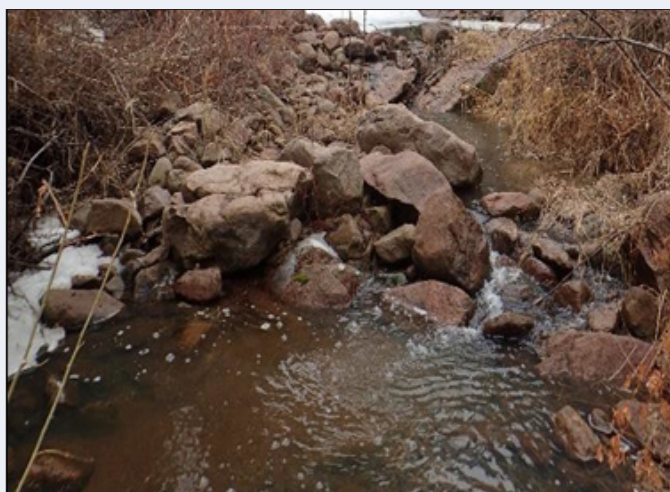
Figure 37. A shallow pool with cobble and boulder serving as grade controls (Photo LG08, RiverRestoration, 2019).

There are a series of shallow pools separated by boulder and bedrock outcrop grade controls (Figure 37). Willows line the channel and banks, along with several medium-size ponderosa pines in and adjacent to the flowing water. At the reservoir inlet, significant sediment deposits below the level of reservoir, influence the stream. In the higher elevations of the stream channel, deposits are composed of sand to large cobble sized material, and approximately 50 feet downstream, deposits are generally sand size. At the time of the assessment, the small amount of flow

passing through the lower sand deposits, flowed sub-grade and then daylighted in a small head-cut at the reservoir water surface. Boulder and bedrock features generally control the grade of the small stream, which appears stable. The stream adds some alluvial sediments to the reservoir, but likely a small quantity compared to other, larger drainages. There is no visual evidence of water quality impacts or pollution.

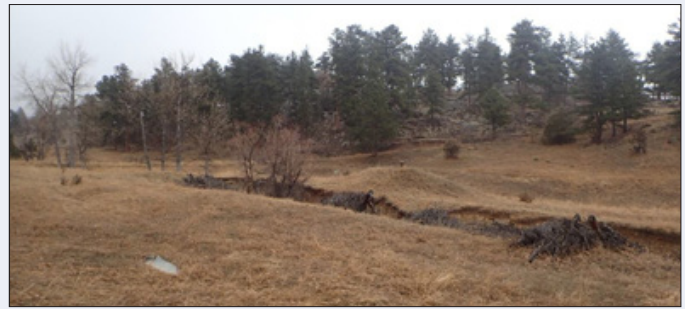
Figure 39. Head cutting and placed wood piles as an erosion control measure (Photo NB14, RiverRestoration, 2019).

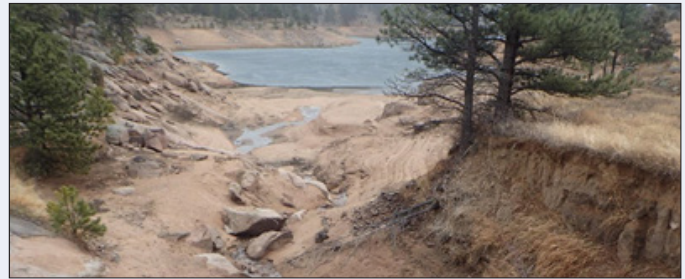
Figure 40. Channel form and avulsion at stream outlet into Ralph Price Reservoir (Photo NB05, RiverRestoration, 2019).

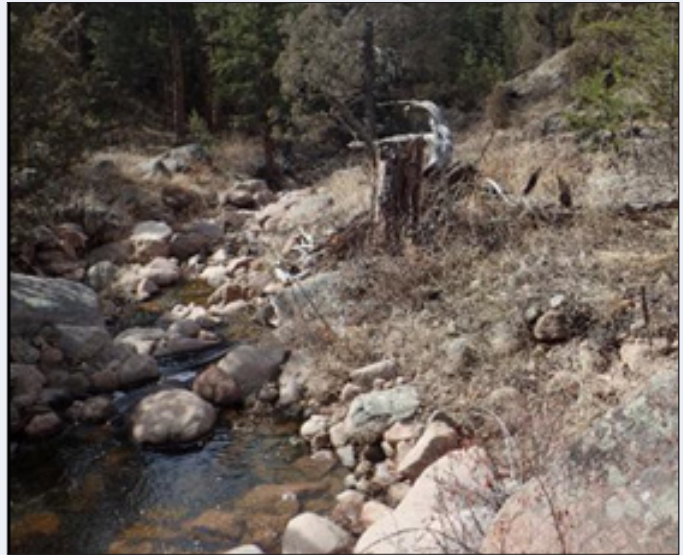
Figure 42. Boulder bed channel form (Photo RG07, RiverRestoration, 2019).

The stream channel ranges from two to five in width on average. The channel bed form can be characterized as step-pool with several small waterfalls and bedrock slides and a few sections of lower gradient riffles and runs with sand, gravel and cobble bed material. There are large deposits of unconsolidated sand, gravel and cobble where the stream enters the influence of the reservoir. The stream flows through a steep, narrow, forested canyon with a low frequently accessed floodplain bench. Much of the streambed and banks are composed of large boulder and granitic bedrock outcrops creating a geomorphically stable form (Figure 42). Where the banks are not composed of granite boulder and bedrock, a topsoil mantel stabilized with grasses, pine needles and leaf litter, willow and other native riparian and upland species meets the streambed at a variety of side slopes up to vertical.

There are no signs of significant incision or avulsion along the stream channel. The grade and alignment of the streambed is primarily controlled by large boulder, bedrock outcrops, and established riparian vegetation. A second smaller ephemeral stream joins Rattlesnake Gulch tributary just downstream of the road crossing. Both streams pass through culverts. The road was overtopped and washed out in the 2013 flood event. The stream appears to be a threshold type stream, likely only transporting a significant sediment load at relatively high flows. The transported bedload is made up of sand, gravel and cobble size material

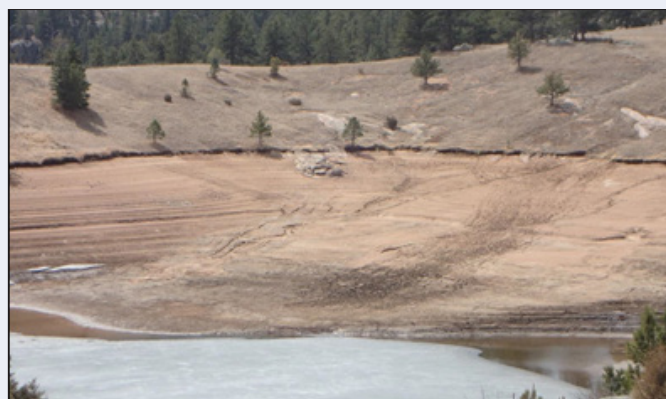
Figure 43. View of rilling through reservoir sediments from overland flow (Photo SB01, RiverRestoration, 2019).

This basin is steeper than the North Borrow Area and does not have any of the drainage swales that were created in the North Borrow Area. Hillslope erosion in the form of rilling and gullying exists on much of this slope and continues all the way to the reservoir (Figure 43). Woody debris has been placed in one area of the hillslope adjacent to the access road in an apparent attempt to check ongoing erosion (SB05.JPG). There is also some erosion on the access road as it appears to be a distinct flow path for rainfall runoff. There is some evidence of soil destabilization from deer and elk

grazing on the unforested hillslope and the reservoir sediments as well (SB08.JPG). There is also an erosional area at the head of the cut from the excavation for the dam material (see picture SB03.JPG and SB04.JPG). Generally, the surface water flow in this drainage can be considered overland flow. There are some collection points where the overland flow has created gullies but there is no well-defined channel. The estimated the 100- year peak flow rate is 38.2 cfs.

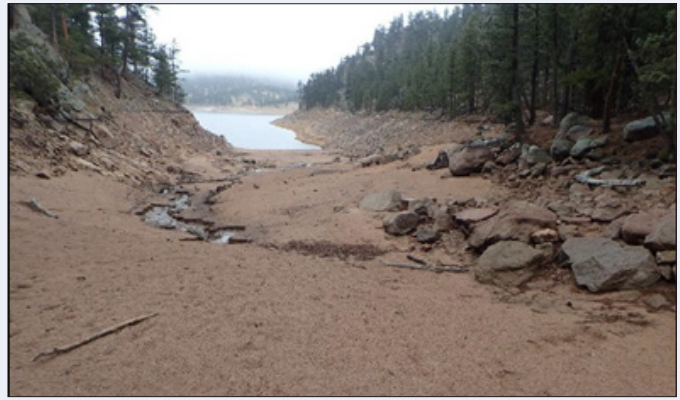
Figure 44. Sand deposits and incision at channel outlet into Ralph Price Reservoir (Photo SC06, RiverRestoration, 2019).

The channel appears to be stable with no sign of significant bank erosion or channel degradation. The channel form suggests a threshold type system that only mobilizes a significant portion of the bed load at relatively high flows. The stream appears to transport relatively small quantities of sand and finer sediments, during more frequent flow events, depositing them in the reservoir inlet cove (Figure 44). There is no evidence of point source or other pollution.

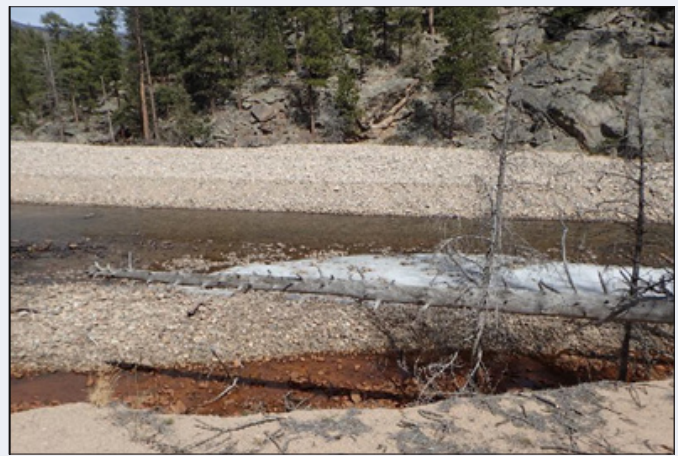
Figure 45. Cobble deposits and staining from localized source, possibly from acid rock drainage (Photo USSV12, RiverRestoration, 2019).

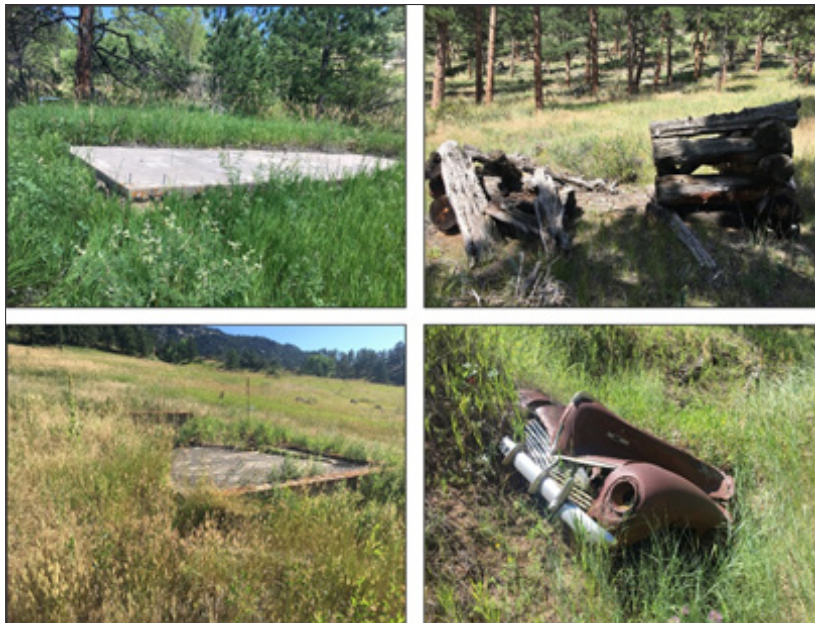
Figure 54. (Top Left and Right): Foundational remains of historic cabins. (Bottom Left): Remains of an historic outbuilding. (Bottom Right): A piece of an old Studebaker left on the Preserve.

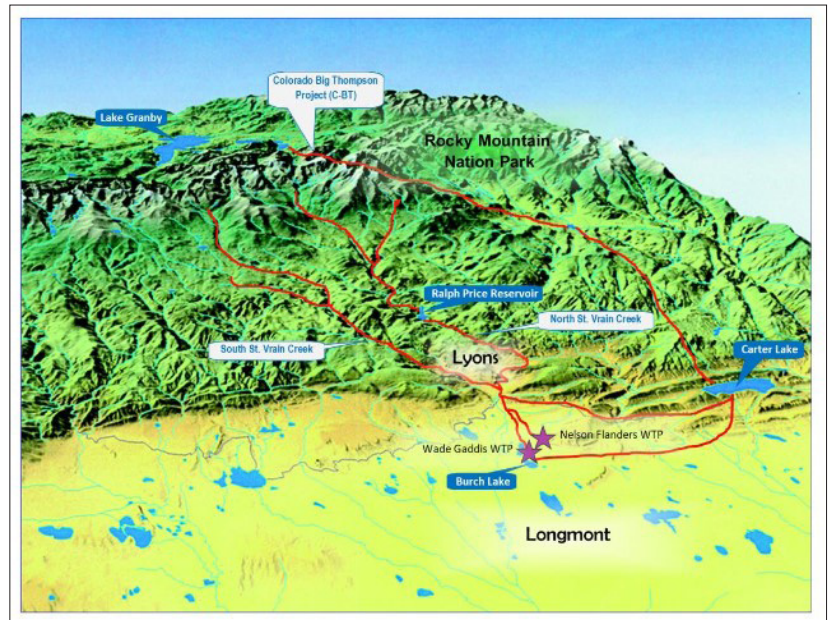
Figure 55. City of Longmont’s drinking water comes from creeks, lakes and reservoirs that are fed by snowmelt and rainfall in the St. Vrain Creek watershed and the Colorado and Fraser Rivers on the western slope delivered via the Colorado-Big Thompson project (City of Longmont, 2022).

To describe the entire profile of Longmont’s municipal water supply and distribution system is beyond the scope of this Plan. These details are available on Longmont’s Water Resources and Supply webpage (2022) as well as in Longmont’s Draft Water Efficiency Master Plan Update (Figure 55) (CH2M, 2017). The Button Rock Preserve system components fall within Longmont’s North St. Vrain Creek raw water collection system which, along with the South St. Vrain Creek system, merge into St. Vrain Creek in the Town of Lyons, Colorado (Figure 56). From Lyons, the system feeds into Longmont’s water treatment plants along with area ditches that deliver raw water to irrigate Longmont’s parks and greenways.

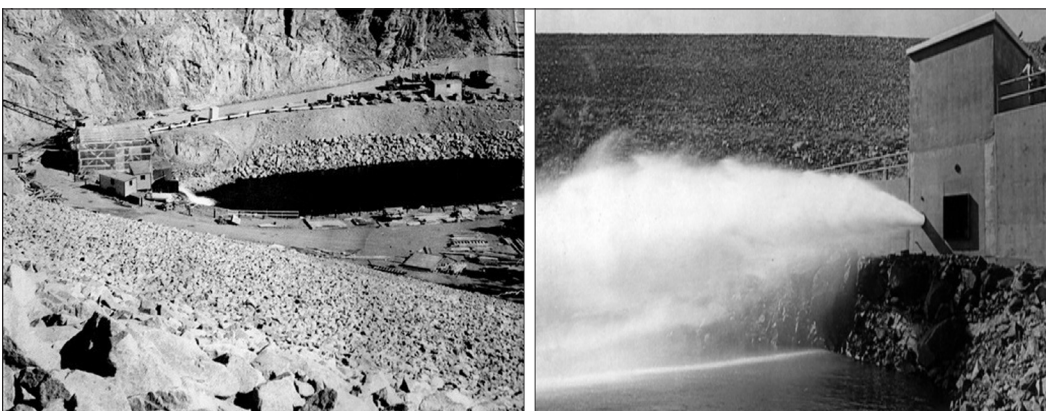
Figure 58. (Left): Button Rock Dam stilling basin and outlet works (1969); (Right): Outlet works bypass pipe, used during low water demand periods. The square opening, designed for a greater volume of water, is used during high water demand periods (1974) (Longmont Museum & Longmont Times-Call collection).

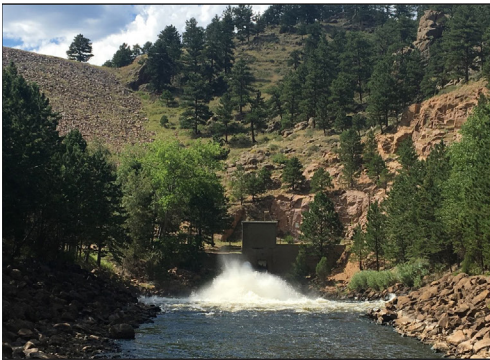
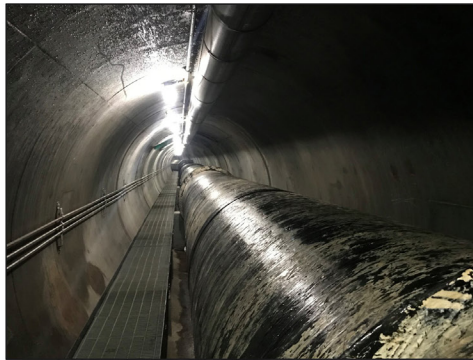
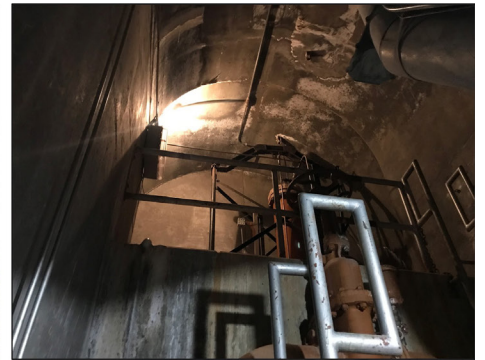
Figure 60. Exterior and interior views of the reservoir outlet house at the base of Button Rock Dam.

The outlet house sits at the bottom of Button Rock Dam. It houses drainage infrastructure and monitoring equipment and its two gates control water releases from Ralph Price Reservoir into North St. Vrain Creek. Water is carried under the road through a 108-inch circular culvert, which can pass up to 875 cfs (Figure 60) (City of Longmont, 2014 (a)). When this capacity is surpassed, water can additionally flow over the concrete spillway.

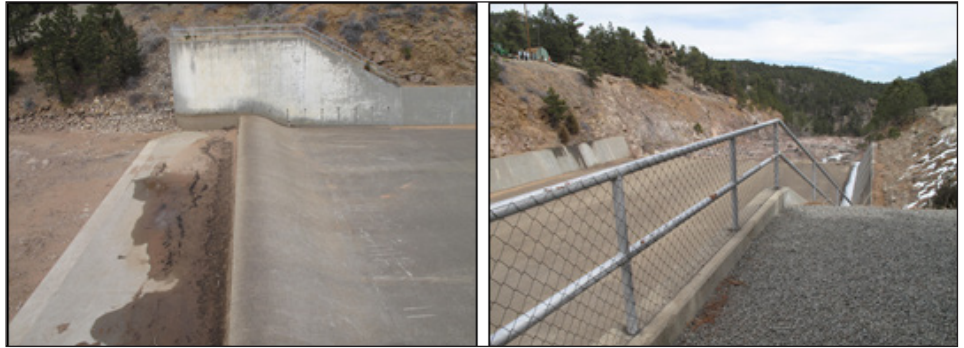
Figure 61. Spillway specifications (City of Longmont, 2019 (b)).

a. Elevation top of Training Walls	6,420.0
b. Elevation Spillway Crest	6,400.0
c. Width at Crest	110.0 ft.
d. Width of Channel	110.0 ft.

The spillway is located at the northeast end of the reservoir. Unlike the outlet structure, it is uncontrolled overflow with a crest elevation of 6,400 ft. and a 32,000 cfs capacity (Figures 61-62). It discharges into a 1,200-foot-long rock channel that drains into the North St. Vrain Creek about one half mile downstream of Button Rock Dam. During the 2013 Colorado Front Range Flood, it was estimated that the spillway passed 1/3 of this capacity (City of Longmont, 2014 (a)).

The spillway is located at the northeast end of the reservoir. Unlike the outlet structure, it is uncontrolled overflow with a crest elevation of 6,400 ft. and a 32,000 cfs capacity (Figures 61-62). It discharges into a 1,200-foot-long rock channel that drains into the North St. Vrain Creek about one half mile downstream of Button Rock Dam. During the 2013 Colorado Front Range Flood, it was estimated that the spillway passed 1/3 of this capacity (City of Longmont, 2014).

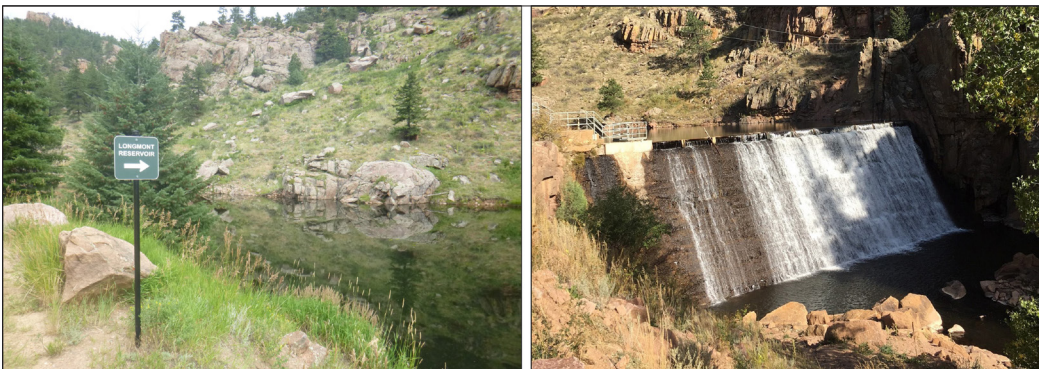
Figure 63. Longmont Reservoir and Dam.

Longmont Reservoir was one of the first components built in Button Rock Preserve in 1912. It is three surface acres in size and has no useable storage capacity. The reservoir and dam were constructed to provide hydraulic head, thus allowing for municipal water supply diversions (Figure 63). After the 2013 flood event, the reservoir had to be drained and massive amounts of sediment and flood debris were removed behind Longmont Dam. This effort was completed to ensure the holding capacity of the reservoir and to allow the structure to continue to divert water into Longmont's raw water system.

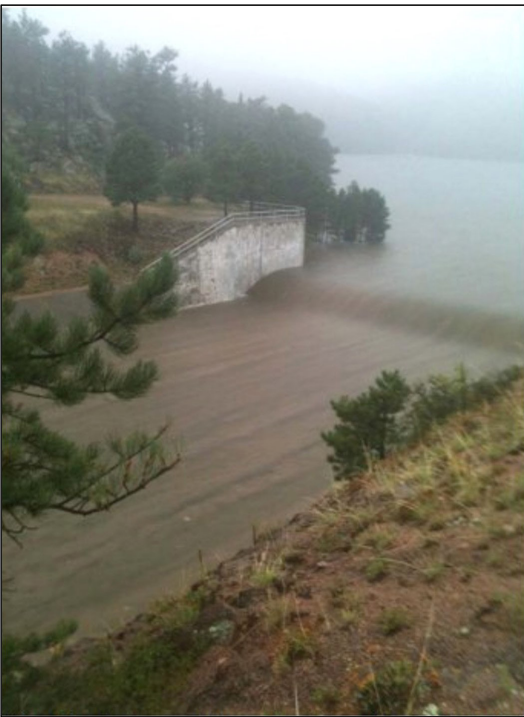
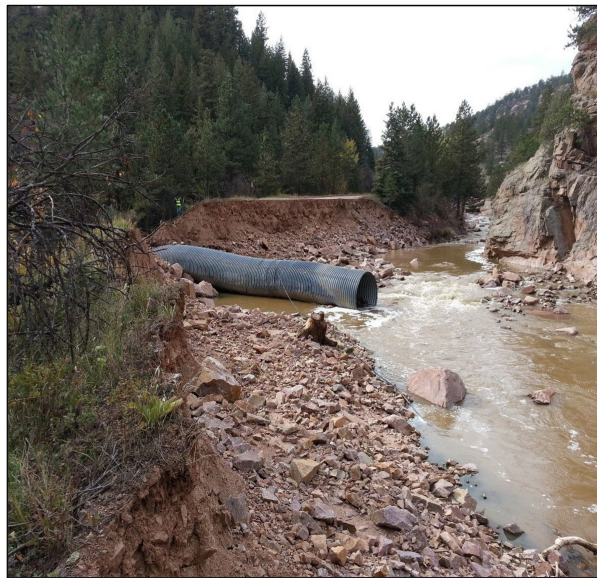
Figure 64. Button Rock Dam spillway (left) on Sept. 13, 2013 with near peak flows of over 10,000 cfs (CDWR, 2014). What remained of Longmont Dam Road (right) after the flood surge in the Preserve.

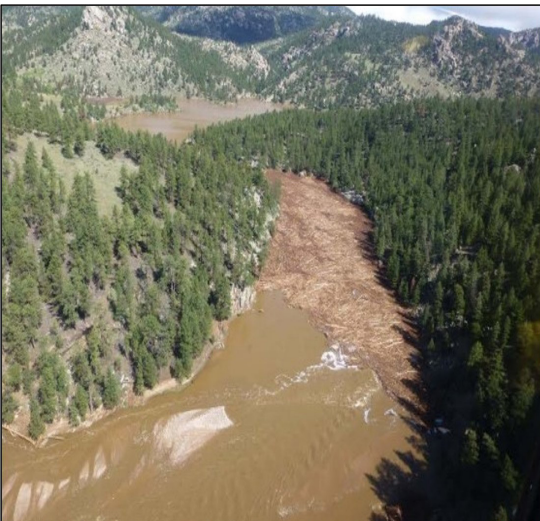
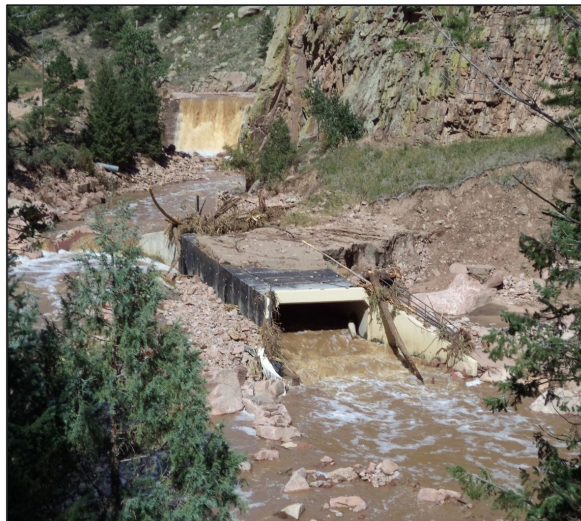
Figure 65. Ralph Price Reservoir (left) with log jam on Sept. 16, 2013 (CDWR, 2014). Damaged bridge culvert (right) below Longmont Dam.

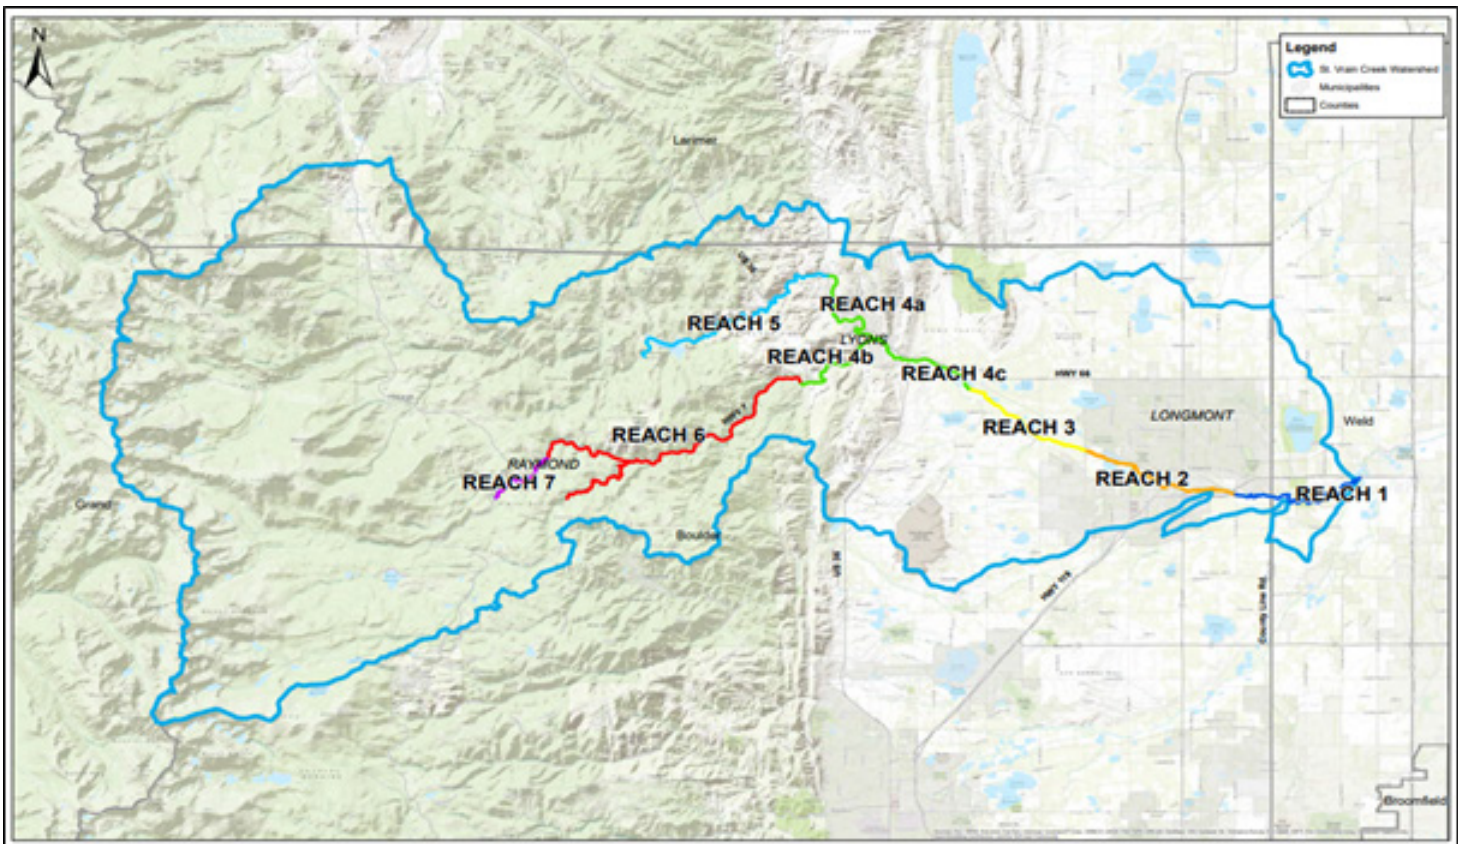
Figure 66. The St. Vrain Creek watershed is also the planning area boundaries for the St. Vrain Creek Master Plan. Within it, St. Vrain Creek and its tributaries are divided into seven reaches, with Button Rock Preserve falling within Reach 5.

The SVMP breaks St. Vrain Creek watershed into seven reaches, describing restoration design strategies and specific restoration projects for each. The plan then makes reach-specific technical recommendations, ranks alternatives and assigns an estimated cost to each item, e.g., natural channel restoration, drainageway crossing repairs, water quality improvement, land acquisition, bank protection, etc. Button Rock Preserve is in the geologically confined upstream portion of Reach 5, which begins at Apple Valley on its downstream end and ends at Ralph Price Reservoir at its upstream end (Figure 66).

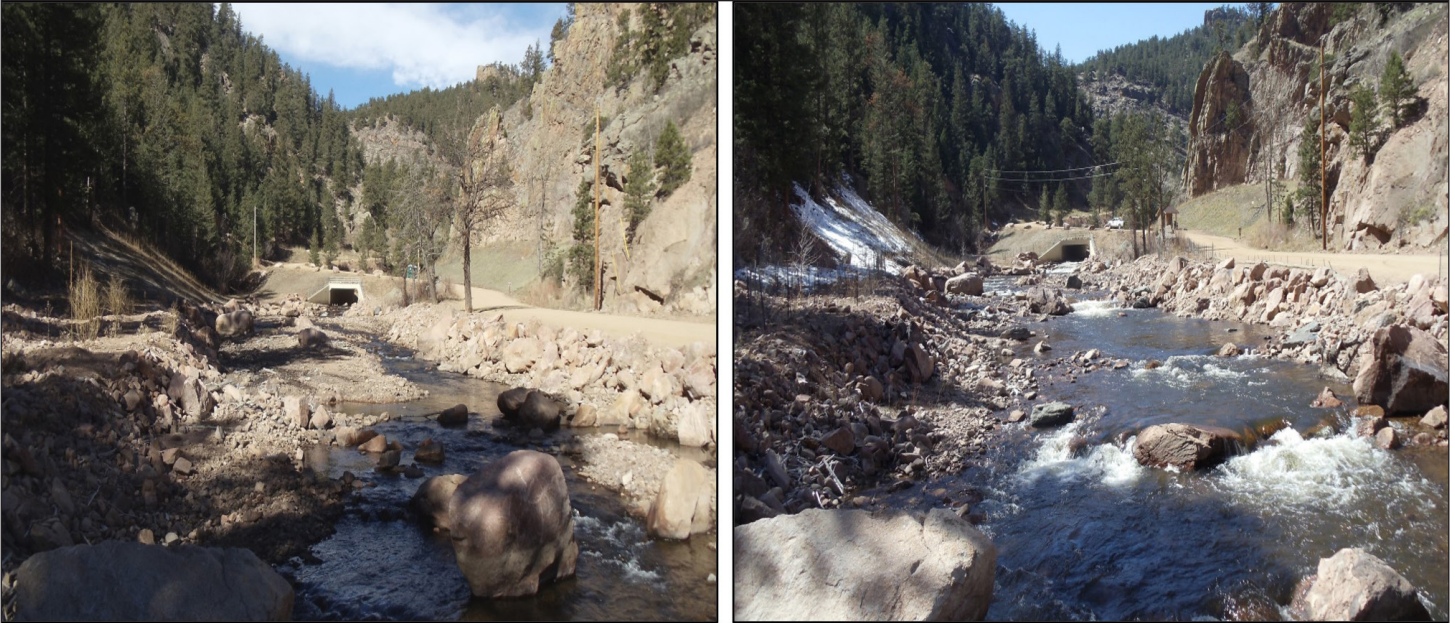
Figure 69. Phase 1: Restoration before and after: Looking upstream from main parking toward the box culvert in the distance. Left photo was taken in March, 2016, right photo of restoration was taken March, 2017.

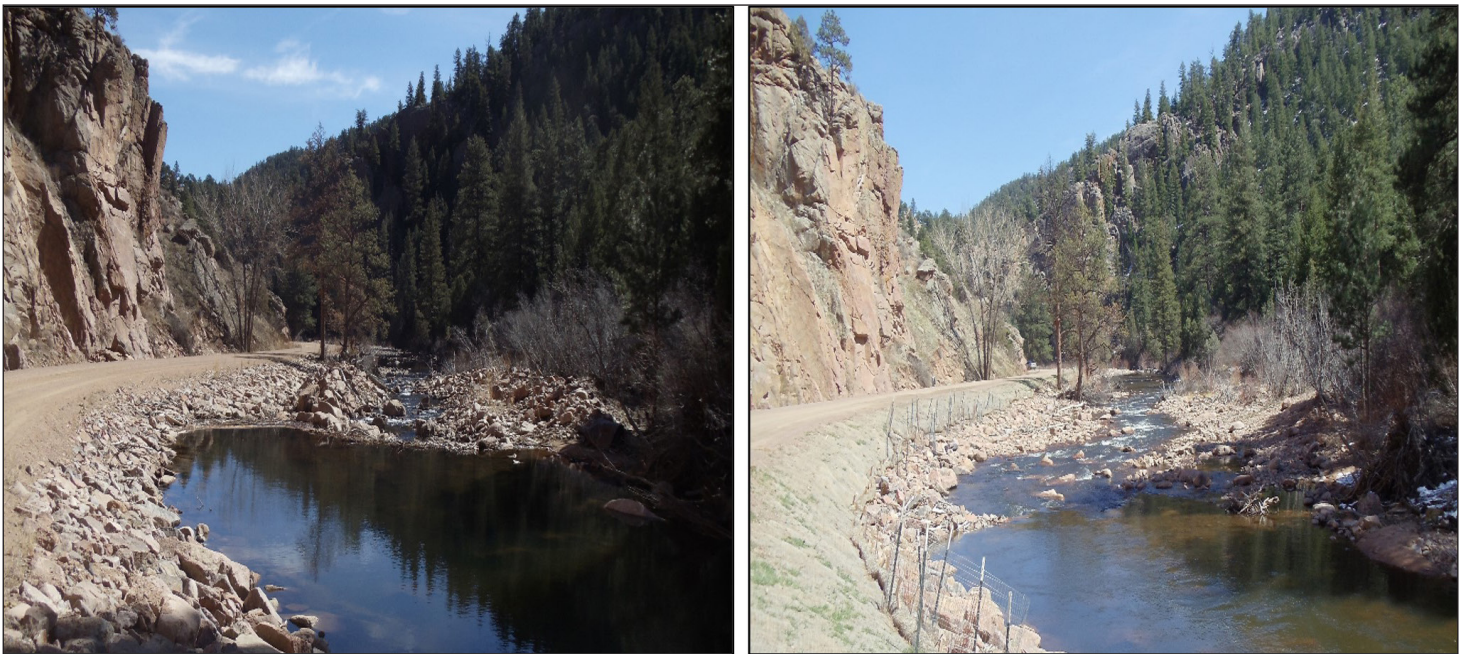
Figure 70. Phase 1 restoration before and after, looking downstream. The left photo (March, 2016) shows the overly wide channel planform and a riprap slope with no vegetation. The right photo (March 2017) is one year later. Sediment deposition had been removed from the channel, the left bank is seeded with erosion control measures in place and native riparian shrubs are planted on both banks.

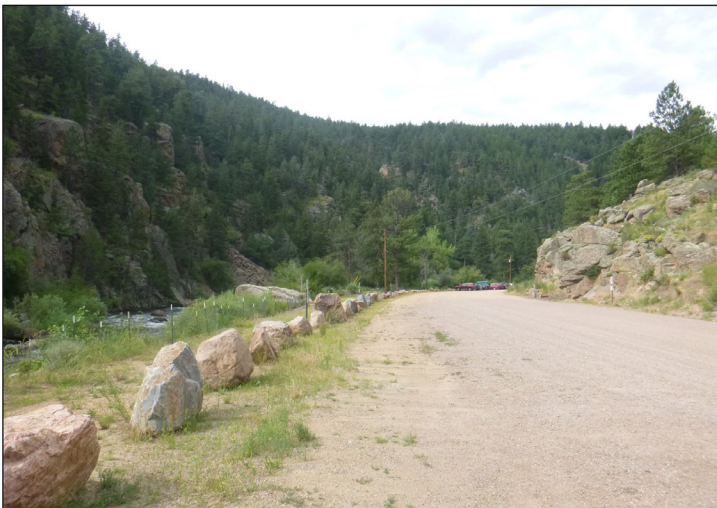
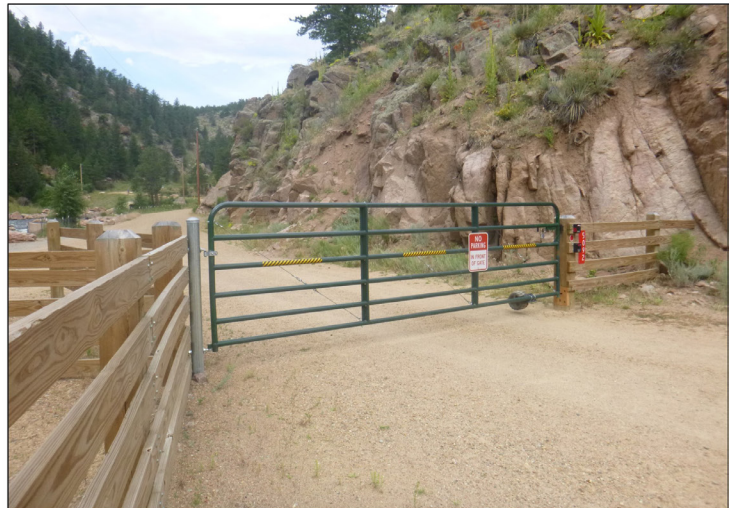
Figure 72. (Left): View of the Preserve's main parking lot from the east. Boulders along the south side keep visitors from pulling too far forward. Parked cars can be seen in the distance. (Right): View of the main trailhead entrance gate. Visitors enter the Preserve on foot to the left of the gate.

Button Rock Preserve's main parking lot is a 650-foot long, gravel lot at the east entrance to the Preserve, downstream of Longmont Reservoir along County Road 80/LDR (Figure 72). The parking lot has space for 65 vehicles and includes four ADA-accessible parking spaces near the Preserve entrance and kiosk. Vehicles park head-in along the south edge of the lot, facing North St. Vrain Creek. There is no parking along the

There are two locking gates located along Fire Road 1/LDR. There is a third gate located on Fire Road 2 that allows pedestrian access to adjacent Hall Ranch. The first gate, at the main trailhead and parking lot, experiences heavy use on a daily basis (Figure 72). The second gate is located on Fire Road 1 in the western Preserve. Both gates are manual. Replacing the gate at the main trailhead with an automated gate may be an efficient solution for staff and residents that need to pass through this area multiple times per day.

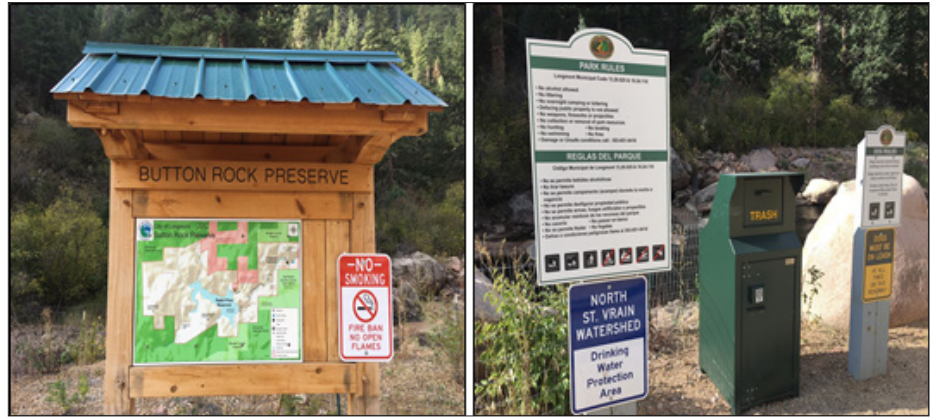
Figure 73. (Left): An informational kiosk showing a map of the Preserve is located at the west end of the main trailhead and parking area. (Right): A large rules and regulations sign and other informational signage is just inside the main trailhead gate along LDR.

An informational kiosk, displaying a map of the Preserve and informational brochures, greets visitors at the main parking lot and trailhead. The permanent map takes up most of the kiosk, leaving little room to post other informational items. Rangers often use the kiosk's support beams to post information about volunteer opportunities, trail closures, and fire restrictions. Other wayfinding and rules and regulations signs are found throughout the Preserve, mainly along trails and roads and to delineate boundaries. The kiosk map and most wayfinding signs have not been updated in many years (Figures 73 and 74).

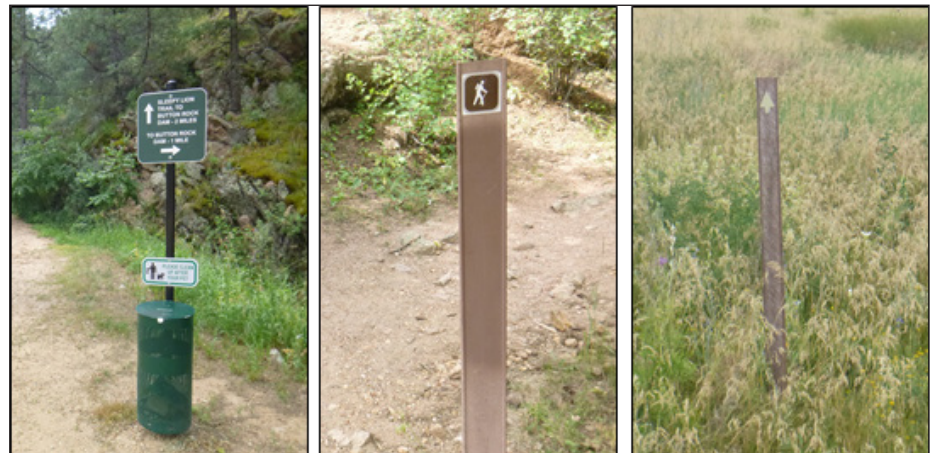
Figure 74. Examples of wayfinding signs at Preserve trails and along roads.

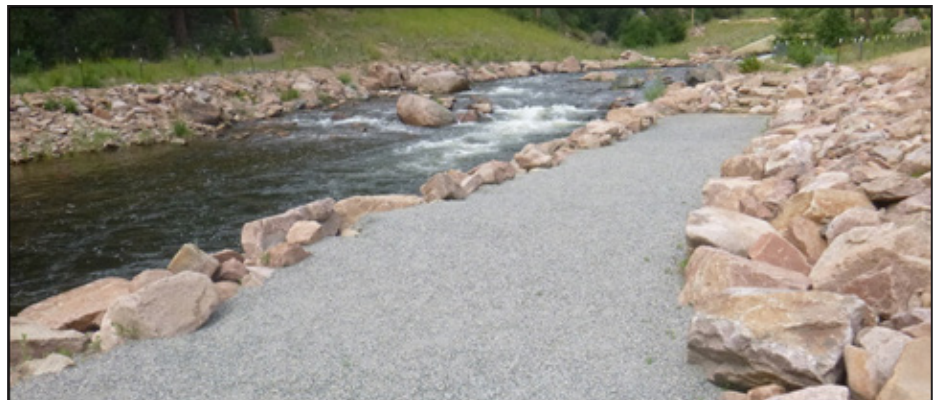
Figure 75. Button Rock Preserve's accessible fishing pier was built after the 2013 flood. It is only a short distance from the main trailhead and parking lot.

The fishing pier is located west of the main trailhead entrance gate, along the north bank of North St. Vrain creek. The pier was built after the 2013 flood. It is ADA-accessible with a flat, eight-foot-wide crusher fine path, flanked on three sides by large boulder rip rap. On the west end of the pier, stone steps connect LDR to the pier. The pier allow visitors to get close to the water and it is designed to allow two to three anglers to utilize the pier at one time (Figure 75).

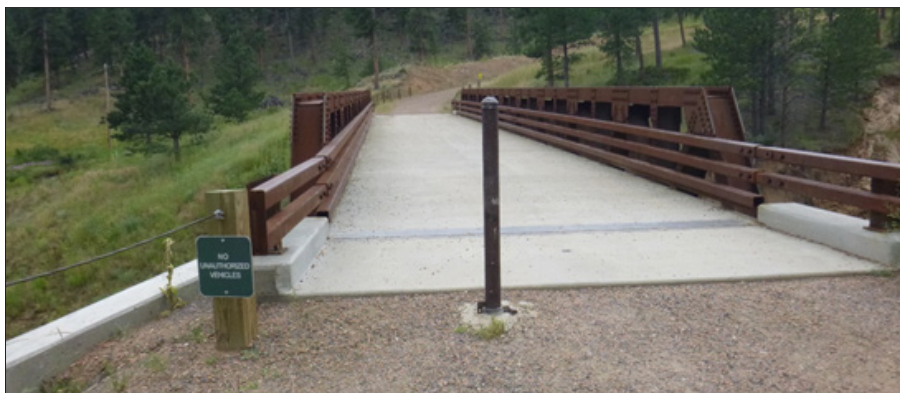
Figure 76. Looking south at the spillway bridge and removable bollard.

A metal bridge spans the Button Rock Dam spillway channel and connects Fire Road 1/LDR to the access road leading to the crest of Button Rock Dam (Figure 76). The spillway bridge was rebuilt after the 2013 flood and completed in 2017. Hikers and anglers can cross the bridge on foot and when needed Longmont staff or emergency services personnel can remove the bollard on the north side of the bridge and cross in a vehicle.

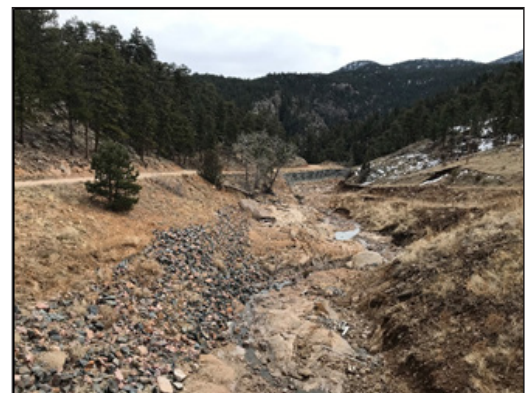
Figure 77. Looking east at the gabion wall that was constructed after the 2013 flood to prevent future erosion of Fire Road 1.
